3D digitization of sacral wooden buildings from the Carpathian Mountains

Conference: USE OF DIGITAL TECHNOLOGIES IN THE DOCUMENTATION, PROTECTION,

MANGEMENT AND DISSEMINATION

OF CULTURAL HERITAGE

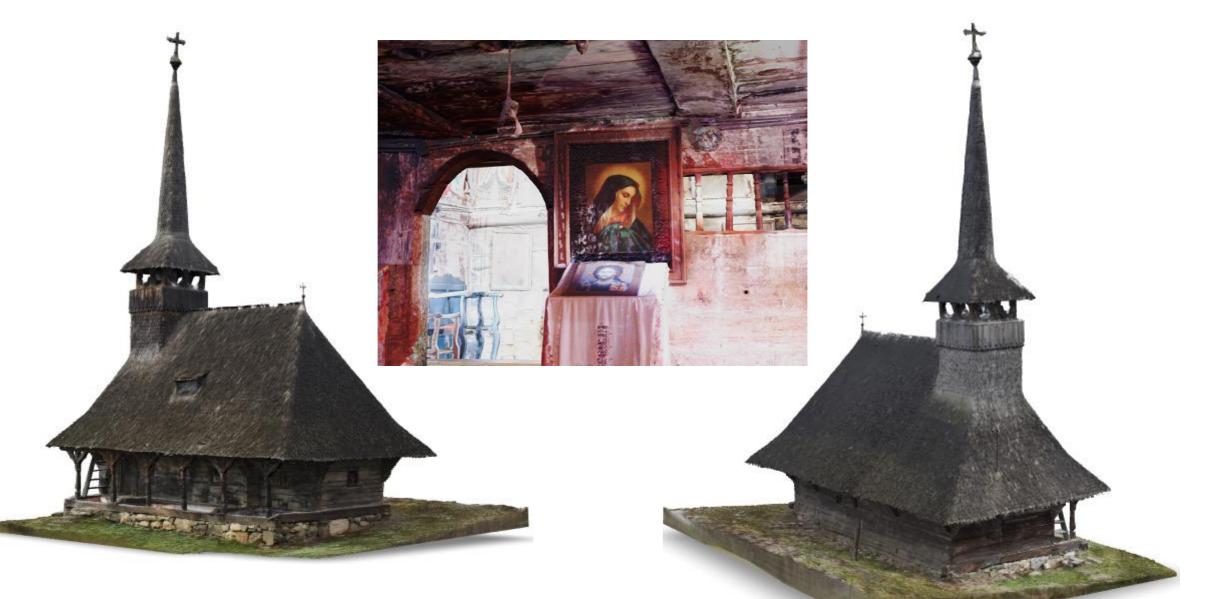
Biserica de lemn din Creaca

The wooden church of Creaca is located in the village of the same name in the Sălaj district. Probably built in the 18th century, but there are no written records on the subject. It is on the new list of monuments under the LMI code: SJ–II–m–A–05044. According to tradition, the church was moved twice. The interior wall painting is attributed to the painter Ioan Pop from Românași.

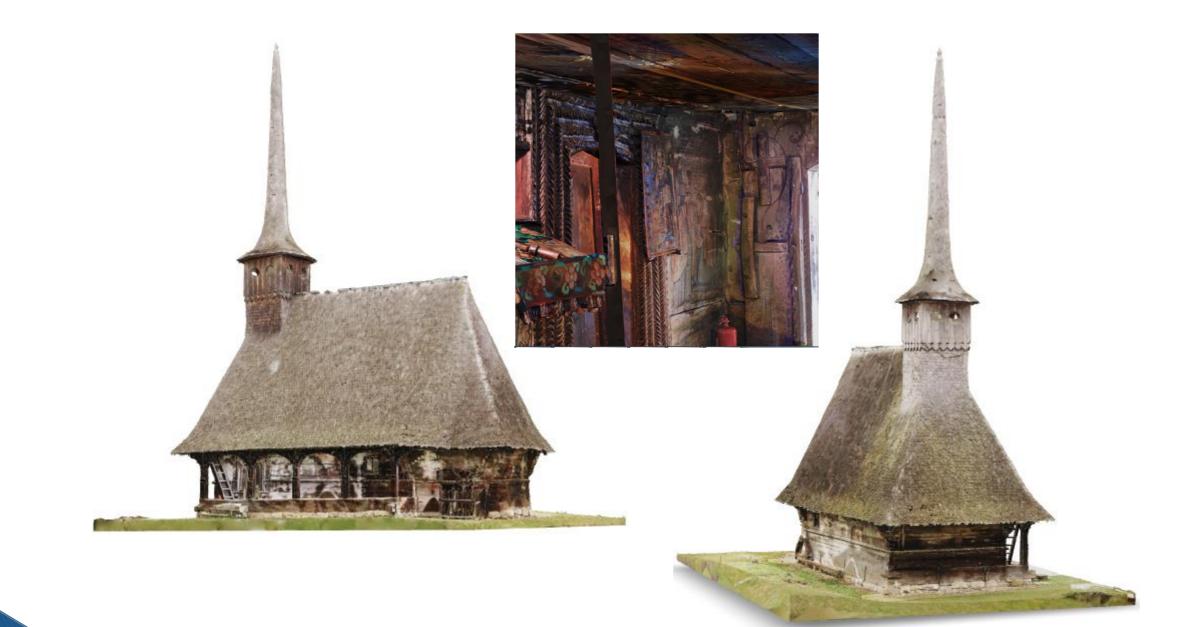
Biserica de lemn din Păușa

The wooden church in Păușa of St. Hierarchy Nicholas (Sfântul Ierarh Nicolae) is located in the village of the same name in the Sălaj district, Romania and dates back to 1730. The object is on the new list of monuments under the LMI code: SJ-II-m-A-05092.

The church was built on a rectangular plan, with a recessed, pentagonal apse. The outer walls are decorated with a rope motif carved in the beams. The entrance door frames are very richly decorated with rosettes, a rope motif (so-called cords), and geometric motifs. The door frames leading from the women's gallery to the main nave are decorated with cord borders and geometric patterns and spiral rosettes. On the fragments of the walls, external paintings have been preserved, on which you can recognize scenes from the New Testament, such as the Assumption of the Virgin Mary or Mary surrounded by the Apostles. The church was restored in 1966–1968.

The church has a window only on the south side, in which there is an almost completely obliterated external wall painting. The eaves (so-called Saturdays) were located on the north side and strongly connected to the top of the building. The church was restored in 1972 and then around 1998.

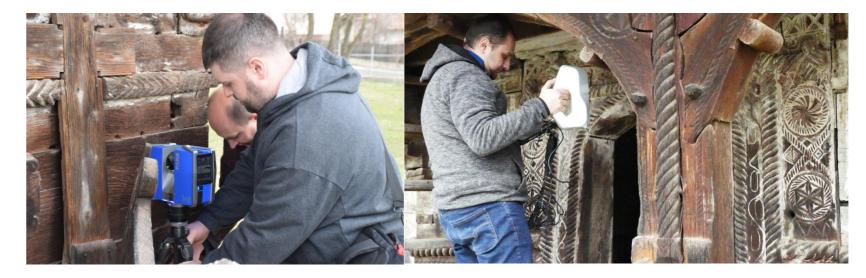
Hardware and software

- 1) Artec Eva structured light 3D scanner
- 2) Faro Focus terrestrial laser 3D scanner
- 3) Artec Studio
- 4) Faro Scene
- 5) Reality Capture

6) Laptop Intel i9, 64 GB RAM, nVidia RTX 2080m
